Accuracy analysis of LiMAP mobile mapping services

PROJECT: Mobile mapping services analysis

ADDRESS: Lithuania & Estonia

SERVICES: LIDAR data collection and feature extraction analysis

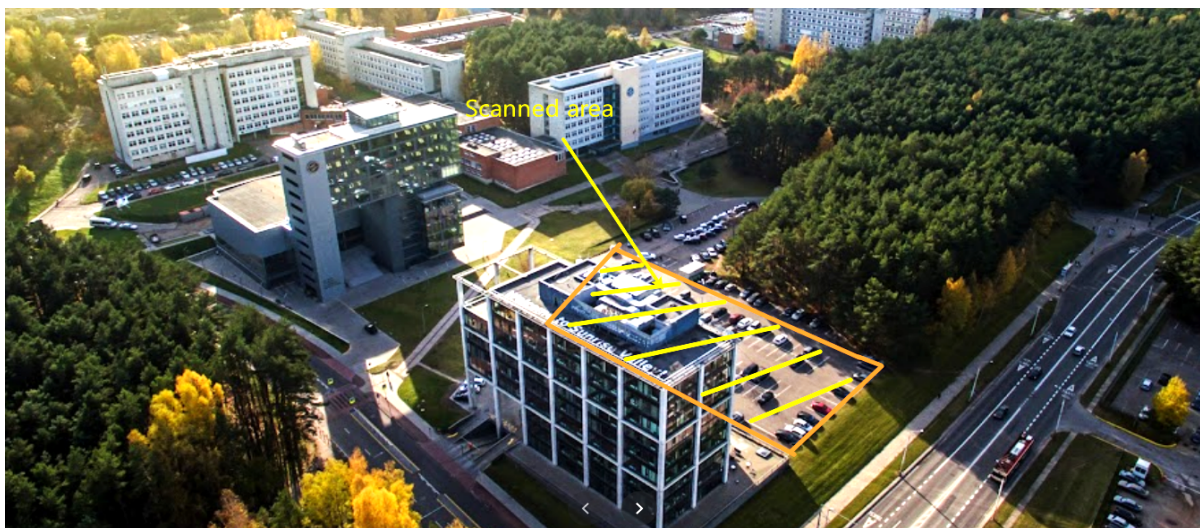
Location: This is an area near Sunrise Valley Science and Technology park, LiMAP head office.
WGS84 coordinate - 54.7233, 25.3375

Situation description: near the project area from the East side stands an 8 floors building with glass material and can cause unreliable signals of the GPS unit, which is integrated into the mobile mapping system. From the West side stands a 15 m height forest area.

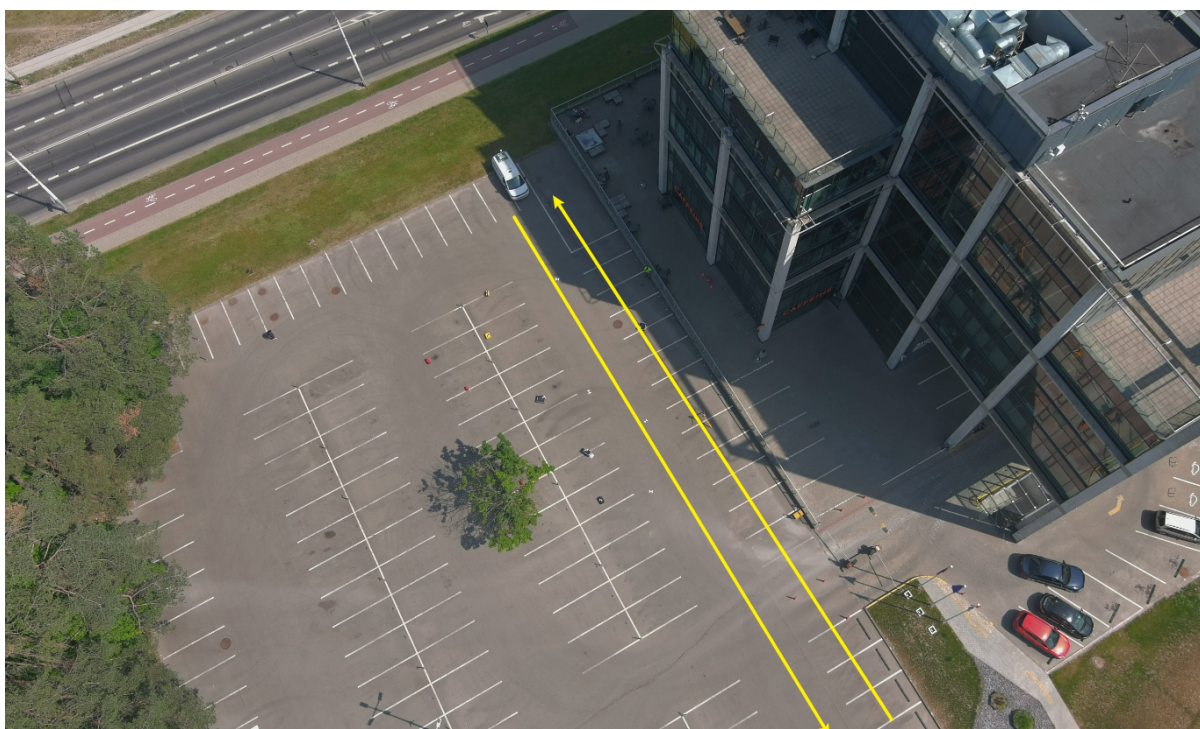
In this project we have done 2 scans, forward and backward. Usually we do 2 runs only on the projects where there is no need for a high precision data. More runs, more precise data we get.

Both scans were done as close as possible to the building to be sure that the condition of the survey was lower than medium.

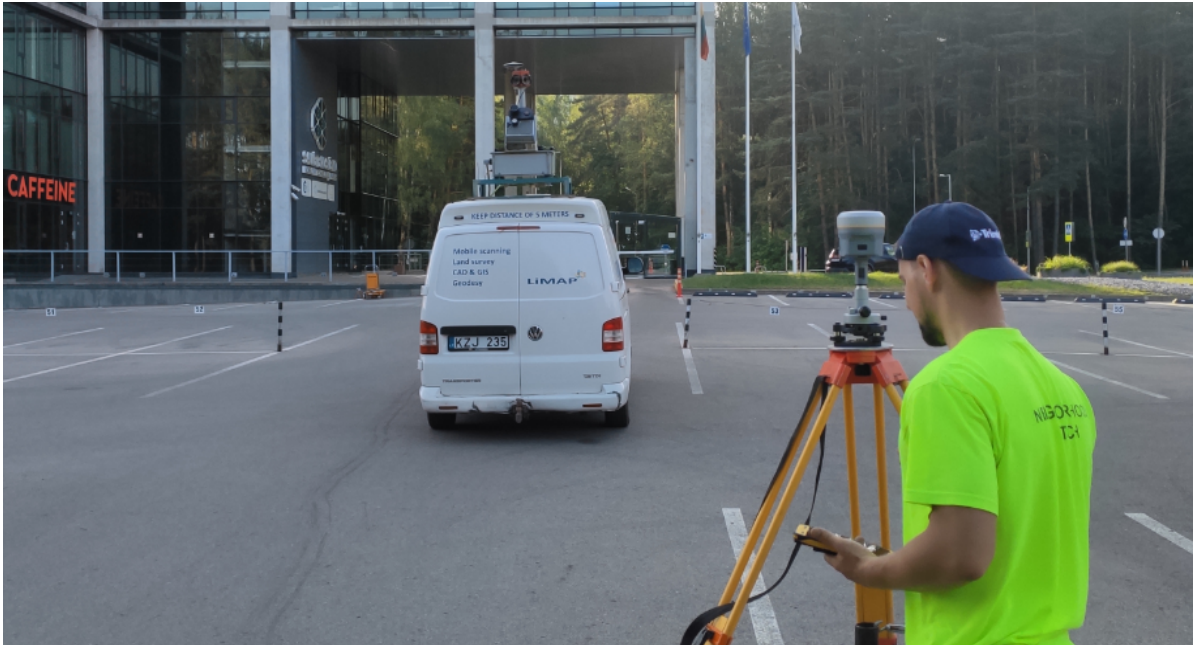
Base station: Our own base station was used. For this one we used the Trimble R12 GNSS unit, which can track all the available satellite signals.

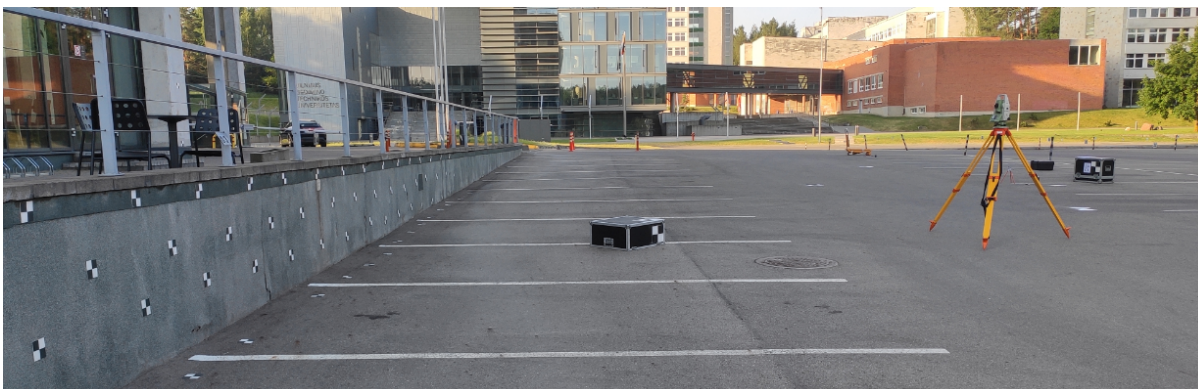
For the traditional survey we used total station Leica TCRM 1203+. Measurements were done in the LKS-94 coordinate system. Total station was orientated on the resection method to 6 base points, which were done on a RTK GPS method, 60 sessions / 3 times a day, results averaged. All control points (CP) on the perpendicular surface were measured with RL function, others with Leica mini prism 360 GRZ101. Using this methodology, CP should reach a precision of ± 2 mm, accuracy ± 15 mm.

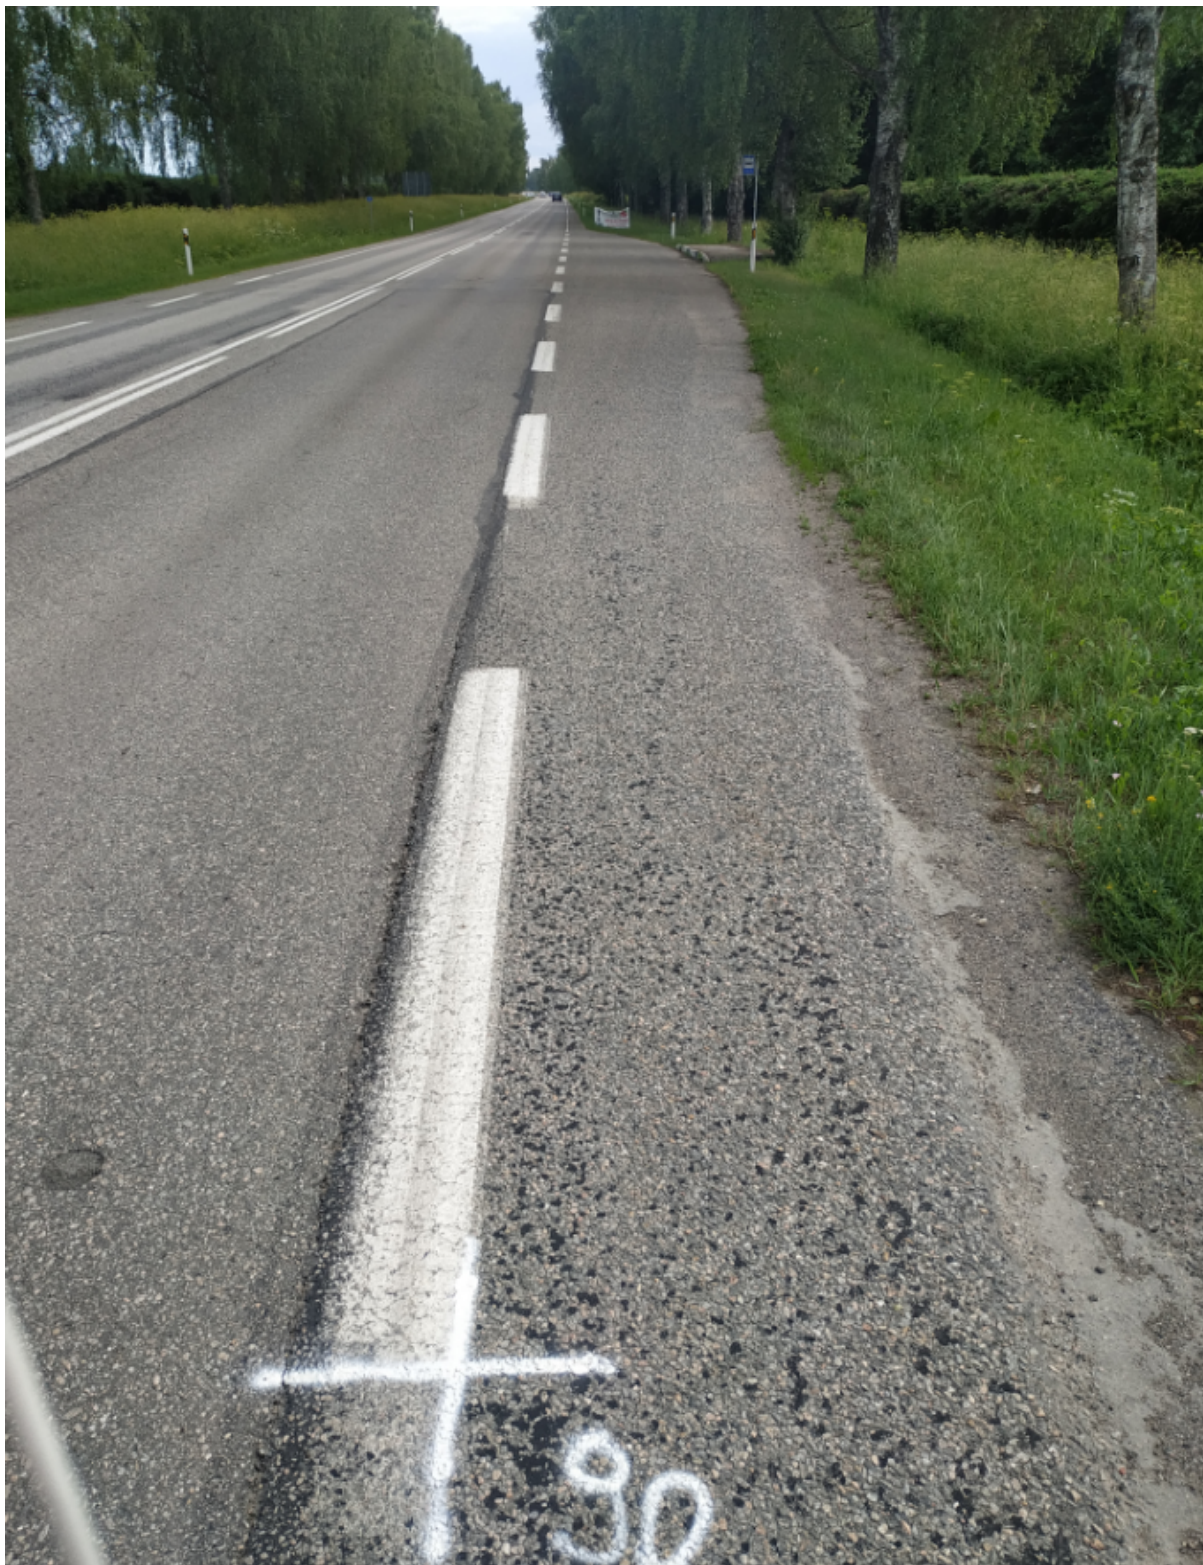
Situation description: length of project is more than 14 km. More than 80 % of the situation is a wide-open area, the other 20% are covered with forest and big trees.

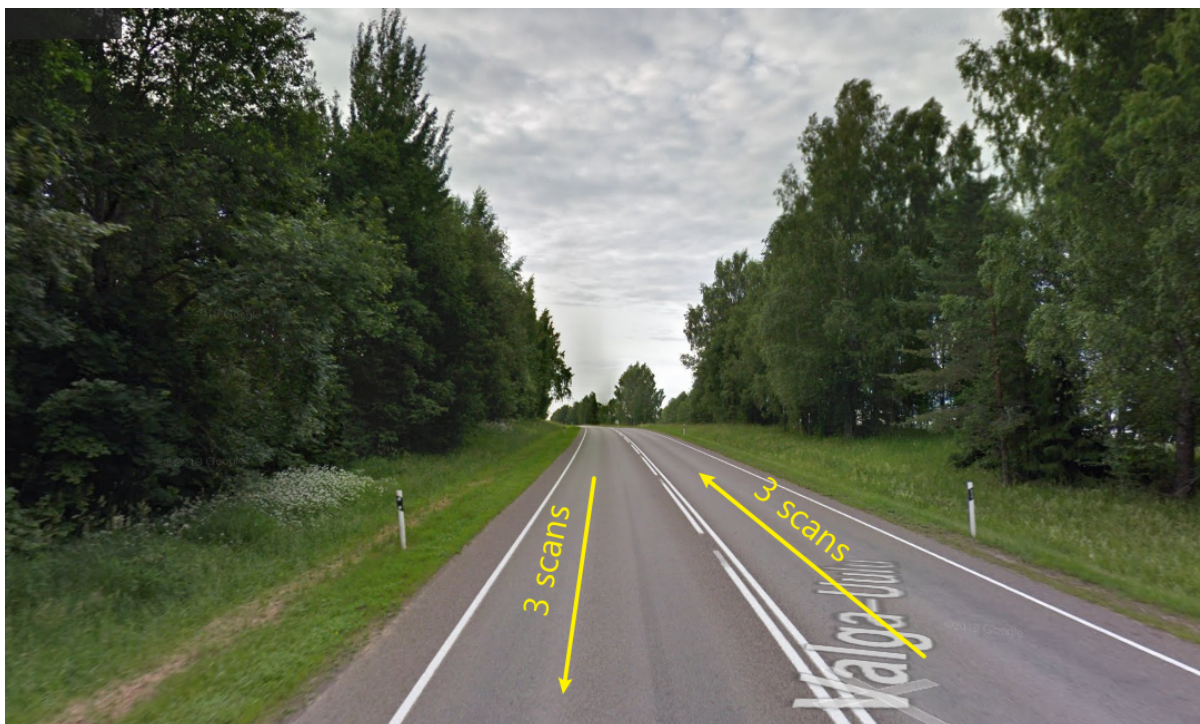
In this project we have done 6 scans of which 3 forward and 3 backward. We are doing 6 scans where higher precision is required.

Base station: we have used a public GPS base station, which can track GPS and Glonass signals. Distance to the base station was around 30 km.

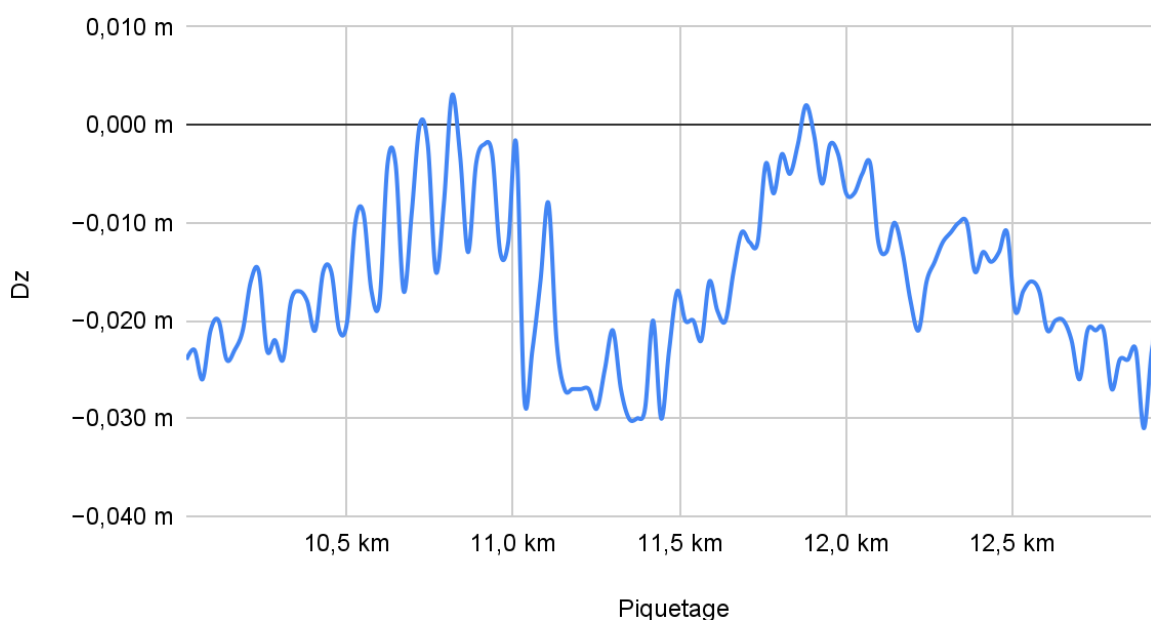
Dz & Piquetage 10 km - 12 km

For a better investigation we divided the 15 km path into 5 parts every 3 km, and we got results. In the first section it goes from the -30mm to +0mm.

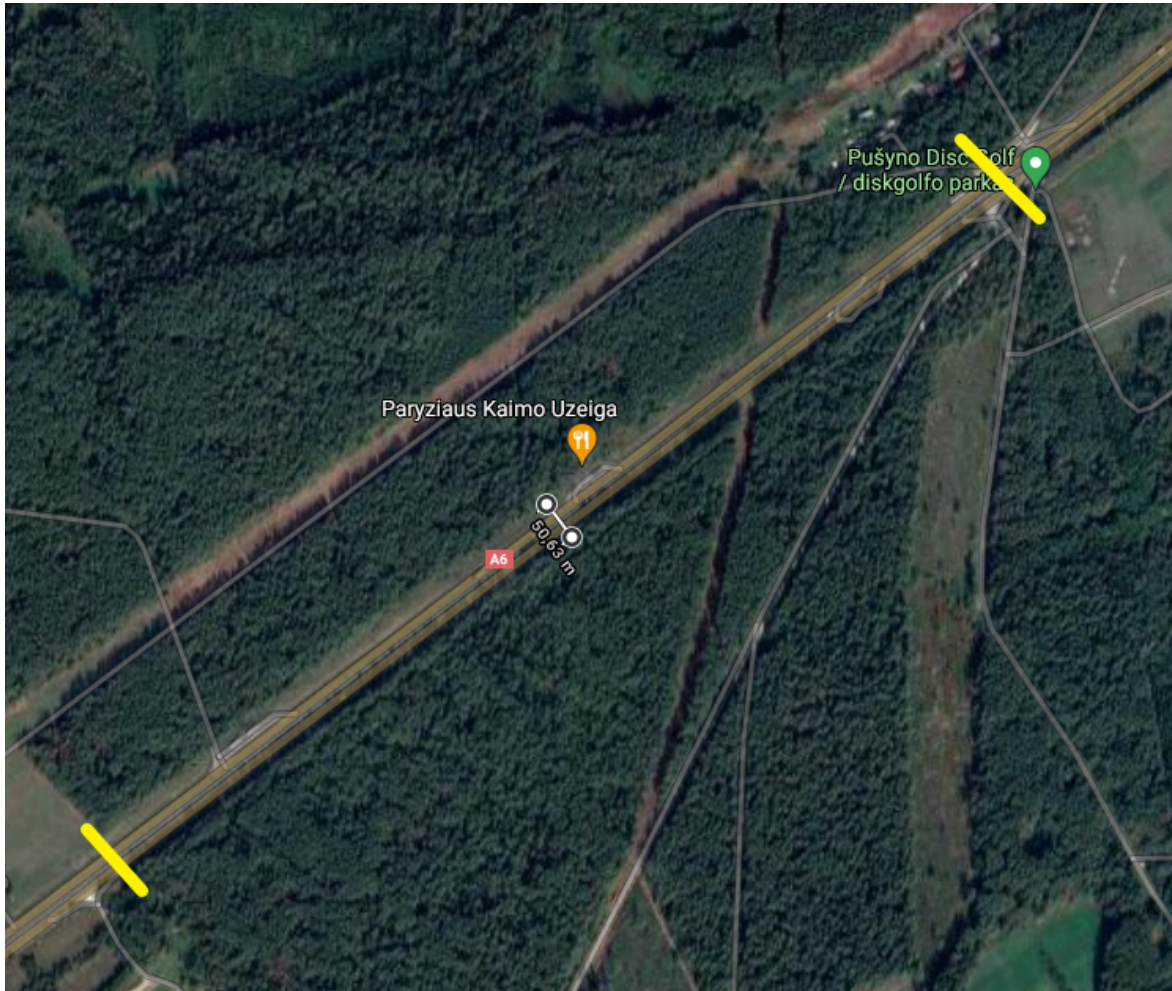
Situation description: length of project is around 1 km. On both sides of the road there is high forest, but basically a lot of satellites were available.

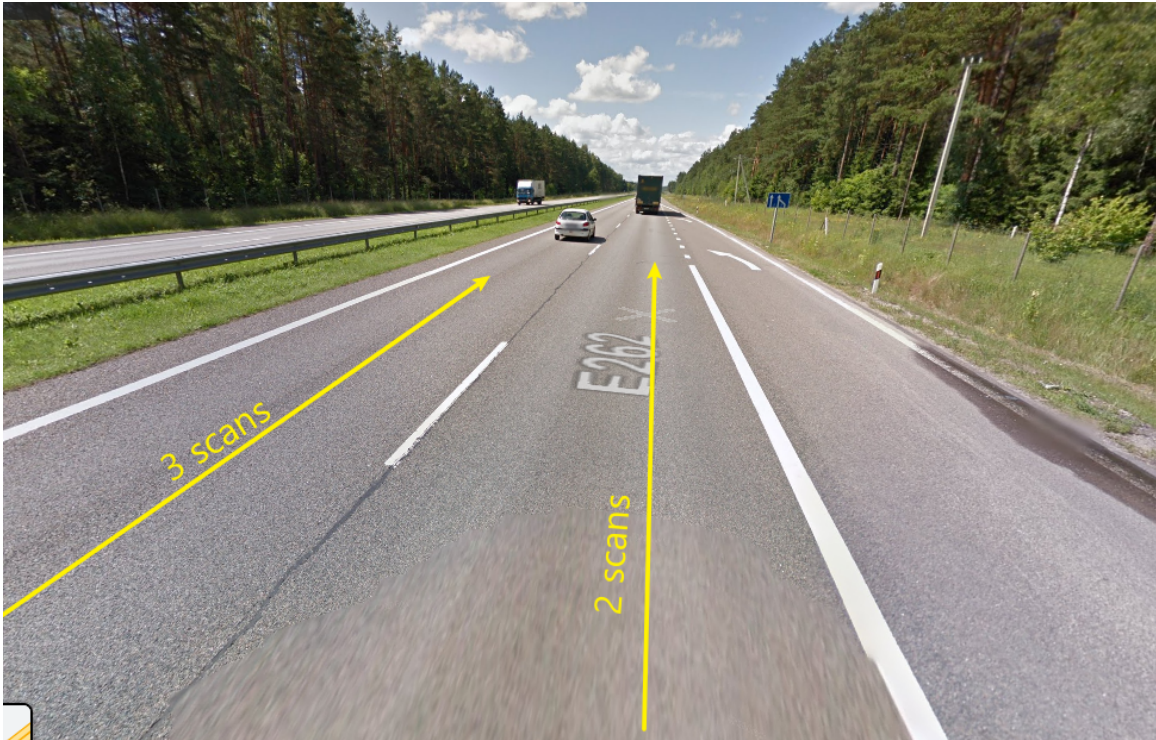
In this project we have done 5 scans, 5 forward and 0 backward.

Base station: was used as a VRS base station, which can track GPS and Glonass signals. Distance to the base station was up to 1 km.

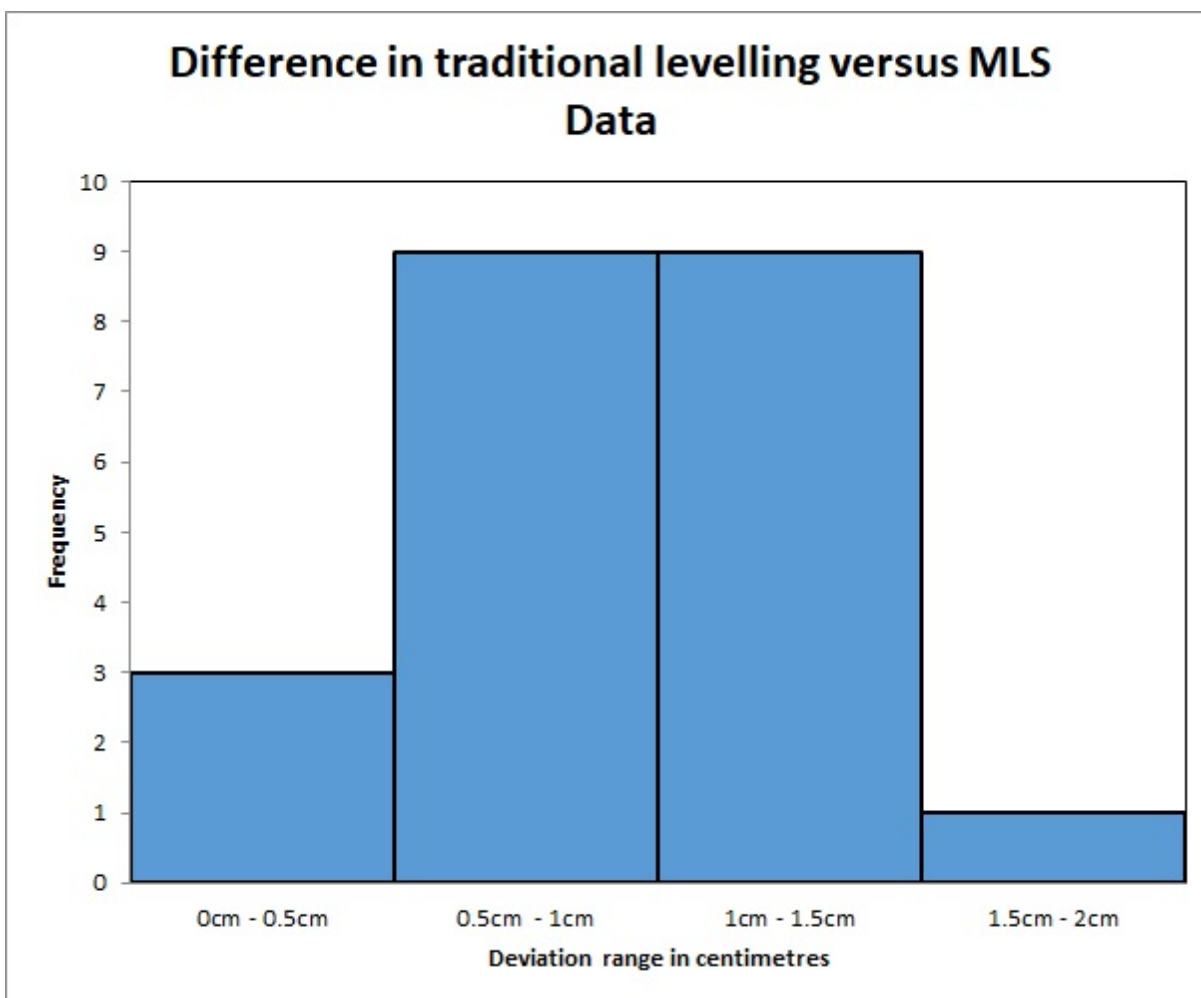
Here we can analyse how deviation looks at the entire project.

If MLS data was shifted by distances $((16\text{ mm}+3\text{ mm})/2=9,5\text{mm})$ in +9,5 mm, MLS data accuracy was +6,5mm.

On this project we reached high accuracy and precision, even without using CP. Even when we get good results, for resurfacing projects we need to combine MLS and levelling data.
